**TRANSPORTATION SCIENCES
CRASH DATA RESEARCH CENTER**

**CALSPAN ON-SITE AIR BAG RELATED CHILD FATALITY INVESTIGATION
CALSPAN CASE NO. CA96-010
VEHICLE - 1996 DODGE CARAVAN SE
LOCATION - TENNESSEE
CRASH DATE - 1996**

1. Report No. CA96-010	2. Government Accession No.	3. Recipient's Catalog No.	
4. Title and Subtitle Calspan On-Site Air Bag Related Child Fatality Investigation Vehicle - 1996 Dodge Caravan SE Location - State of Tennessee		5. Report Date: --

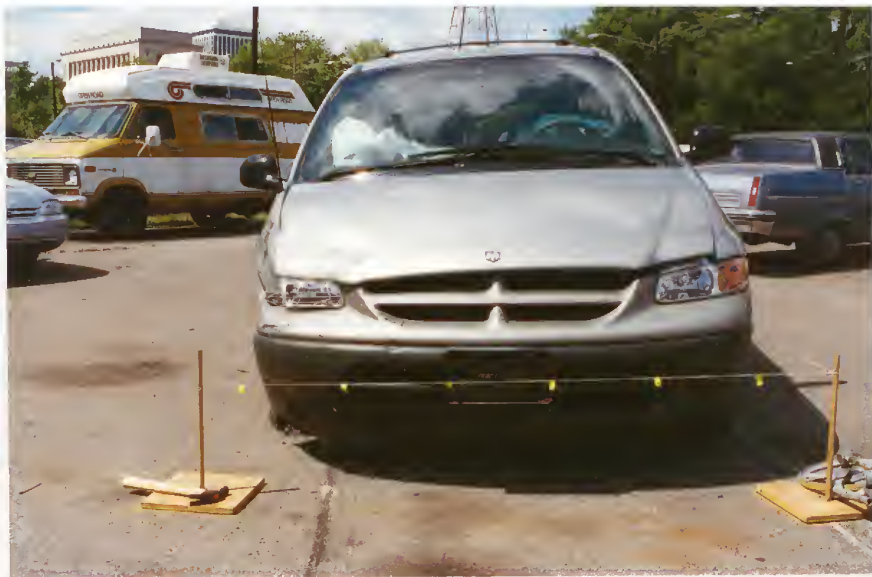
The 1996 Dodge Grand Caravan SE sustained moderate damage to the front right area of the vehicle as a result of its impact sequence with the left front side area of the 1988 Mercury Cougar. The direct contact damage began 12.7 cm (5.0 in) right of center and extended 66.0 cm (26.0 in) to the front right corner. Maximum residual crush was 3.3 cm (1.25") located at the right corner of the bumper reinforcement bar. The documented crush profile over the full width of the reinforcement bar was as follows: C1=0, C2=0, C3=0, C4=0.6 cm (0.25 in), C5=1.0 cm (0.38 in), C6=3.3 cm (1.25 in). Damaged components included the front bumper fascia, bumper reinforcement bar, hood, right headlamp assembly, and the right front fender.

28. Frontal damage to the Dodge Caravan.

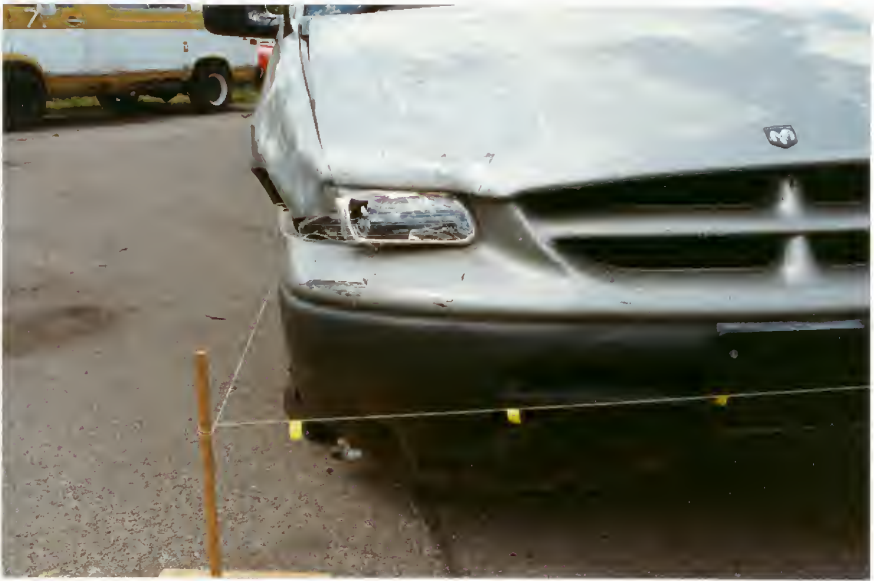
30. View of the direct contact damage to the Dodge Caravan.

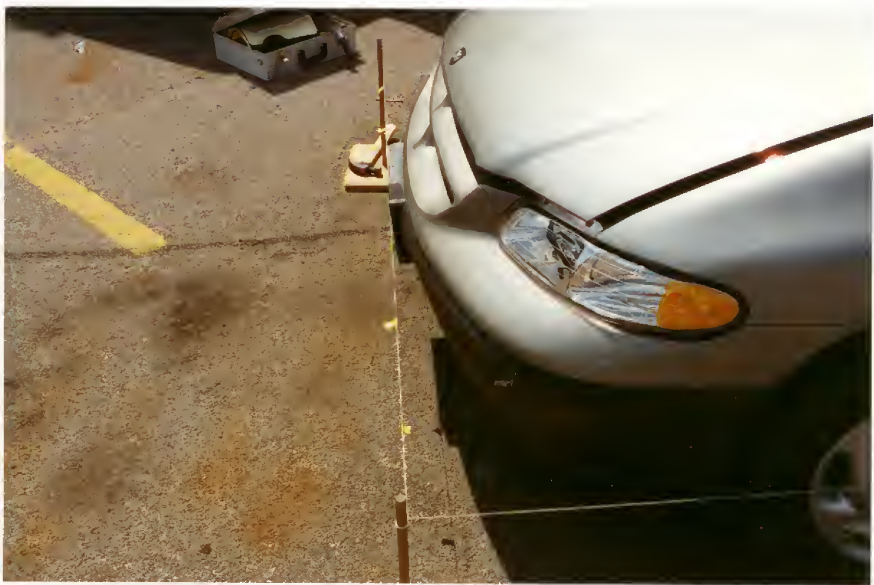
31. Left lateral view of the frontal crush to the Dodge Caravan.

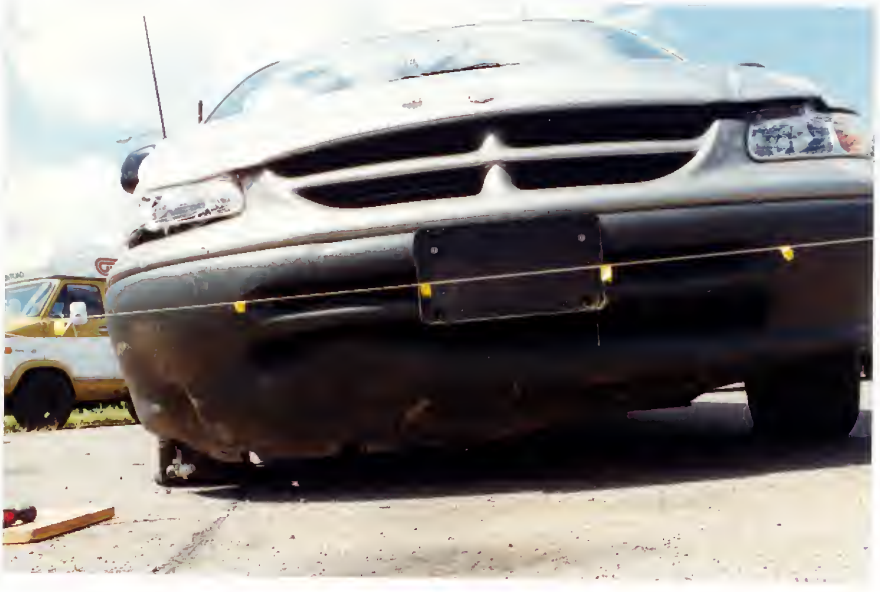
As the Caravan came to rest, the front right undercarriage area impacted a drainage ditch which abraded the underside of the bumper fascia. The contact damage began at the right corner of the fascia and extended 115.6 cm (45.5 in) to the left. The air dam aspect of the fascia was displaced upward approximately 3.8 cm (1.5 in).

34. Front view of the damage to the lower surface of the bumper fascia.

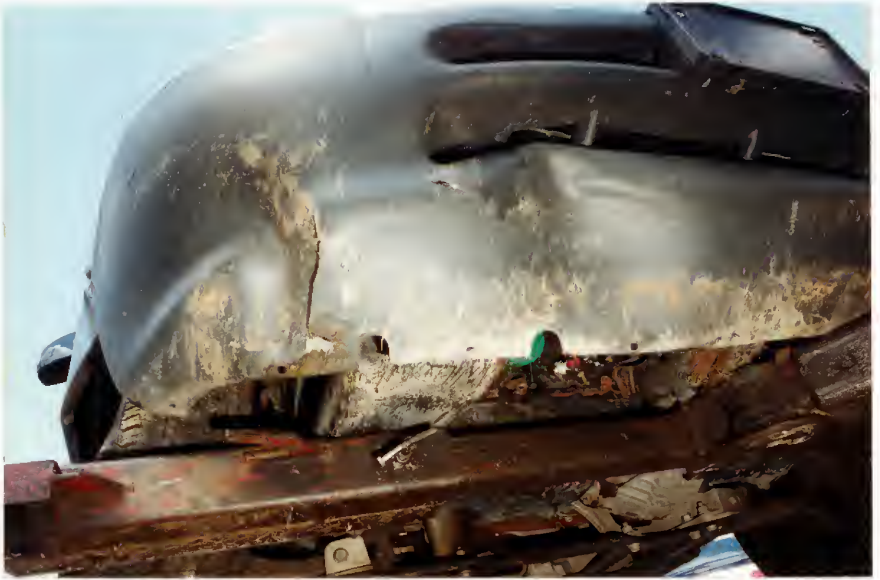
36. Close up view of damage to the lower surface of the bumper fascia.

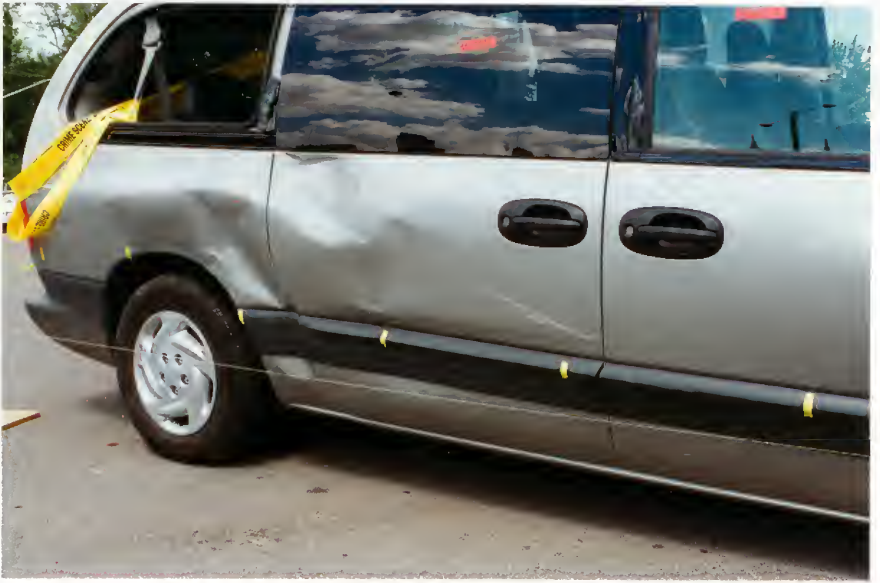
Secondary damage resulted from a subsequent sideslap impact with the Mercury Cougar. The direct contact damage began 66.8 cm (23.6 in) aft of the right rear axle and extended forward 265.4 cm (104.5 in). A maximum lateral deformation of 3.2 cm (1.25 in) was located 54.6 cm (21.5 in) forward of the right rear axle at the base of the C-pillar. The superficial crush profile was as follows: C1=0 cm, C2=1.9 cm (0.75 in), C3=0.6 cm (0.25 in), C4=1.3 cm (0.5 in), C5=0 cm, C6=0 cm.

44. Right rear side slap damage to the Dodge Caravan.

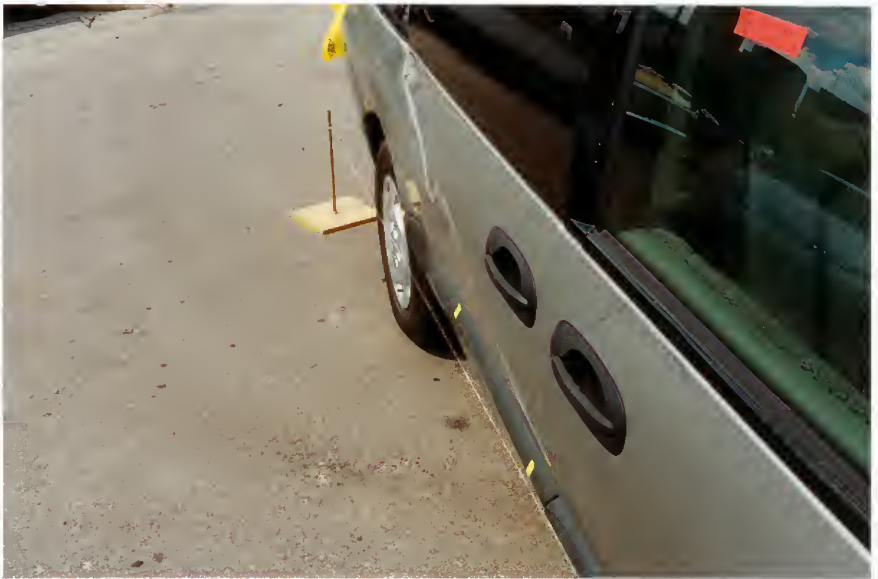
45. View of the right side direct contact damage.

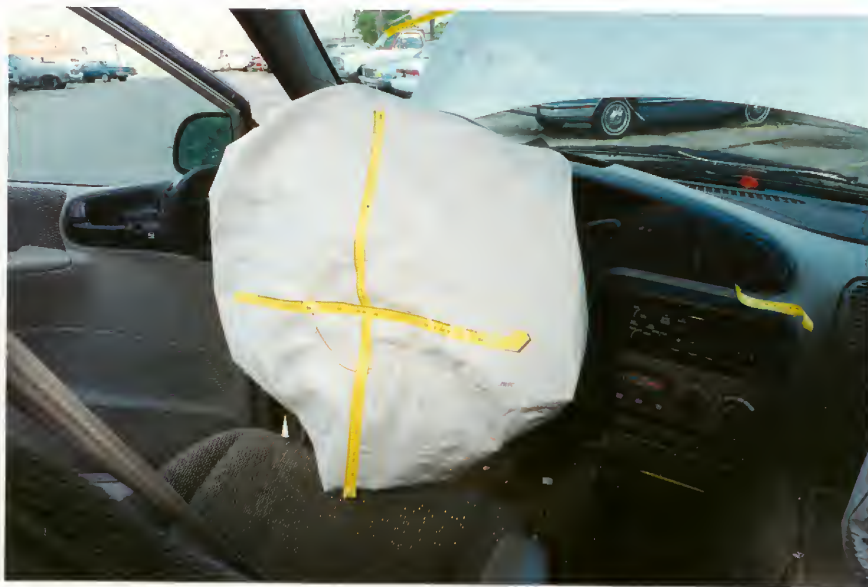
There was no damage to the deployed driver air bag. There were no lipstick or makeup transfers on the bag, however, numerous dirt/grease-type transfers were noted over the face of the bag which appeared to have resulted from post-crash handling of the bag. In addition, nine (9) blood spatters were documented on the lower left quadrant, 6.4-12.7 cm (2.5-5.0 in) down and 5.7-13.7 cm (2.25-5.4 in) left of center (refer to Photograph No. 53). These probably resulted from expulsion of blood from the right front child passenger or from the driver attending to the passenger immediately following the crash.

52. Overall view of the deployed driver side air bag.

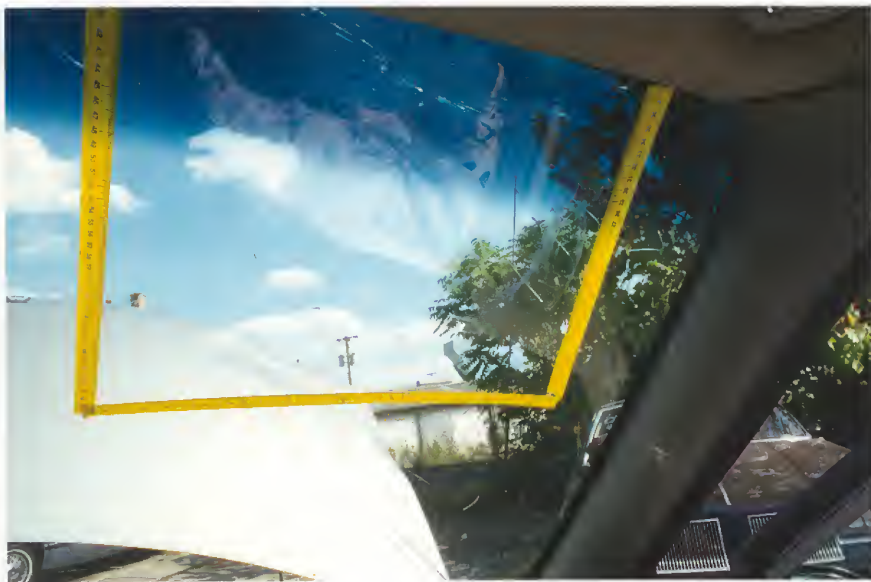
The forward position of the child occupant pre-crash, altered the normal deployment path of the air bag, deflecting the bag upward into the windshield and rearview mirror. Bag contact with the glazing was evidence by air bag fabric transfers on the glass and a fracture to the windshield. The rearview mirror was subsequently separated from its mount and displaced to the left.

65. Overall view of the windshield fracture caused by the deploying passenger side air bag.

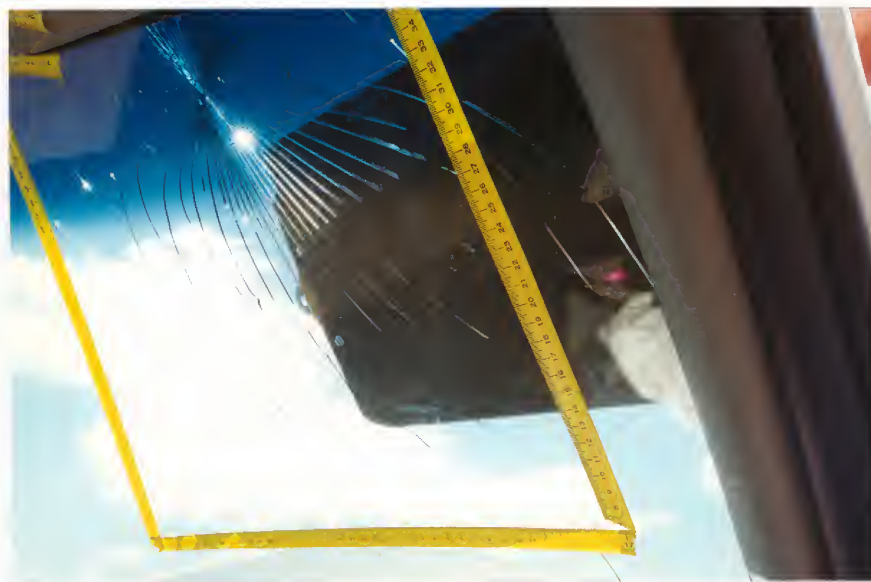
66. Right view of the windshield fracture and air bag fabric transfers.

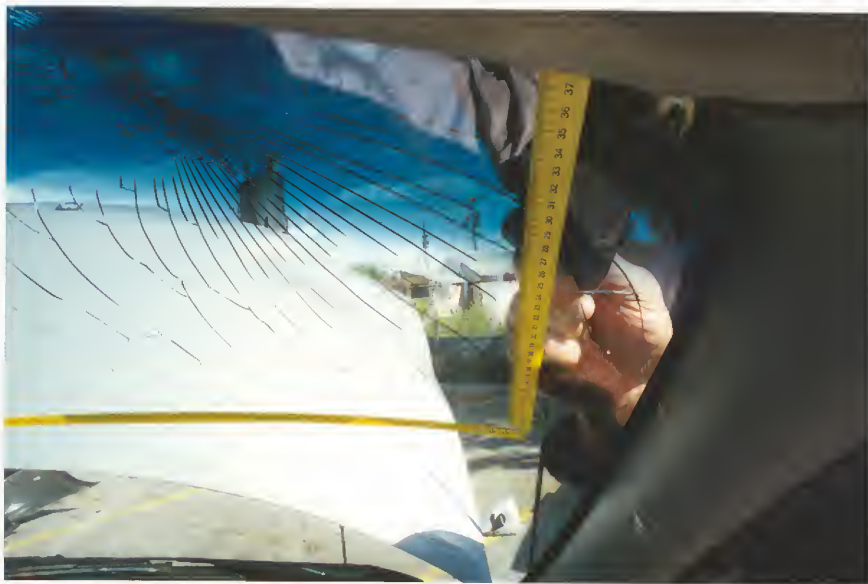
67. Close-up view of the windshield fracture and the air bag fabric transfers.

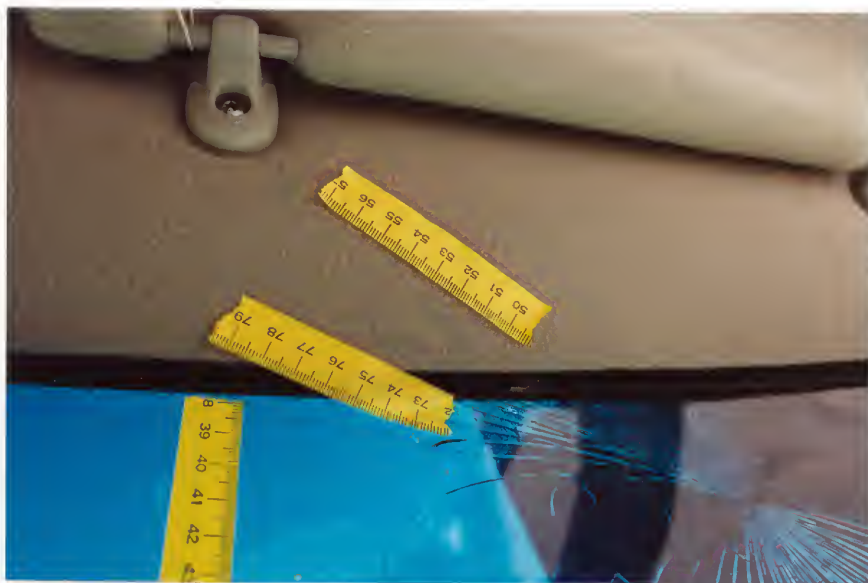
The deployment path of the passenger side air bag was altered by the forward position of the front right child passenger which resulted in bag contact to the windshield, headliner, and the rear view mirror. A large air bag fabric transfer was located to the windshield 35.6-54.6 cm (14.0-21.5 in) right of the vehicle's centerline and 2.5-31.8 cm (1.0-12.5 in) below the windshield header (refer to Photograph No. 66). A windshield spider web-type cracked was located 41.3 cm (16.25 in) right of center and 5.1 cm (2.0 in) below the headliner (refer to Photograph No. 65-67). Also, an air bag fabric abrasion was located on the headliner 27.9-33.0 cm (11.0-13.0 in) right of center which extended 1.3-5.1 cm (0.5-2.0 in) rearward (refer to Photograph No. 68).

68. Close-up view of a fabric abrasion on the header/headliner.

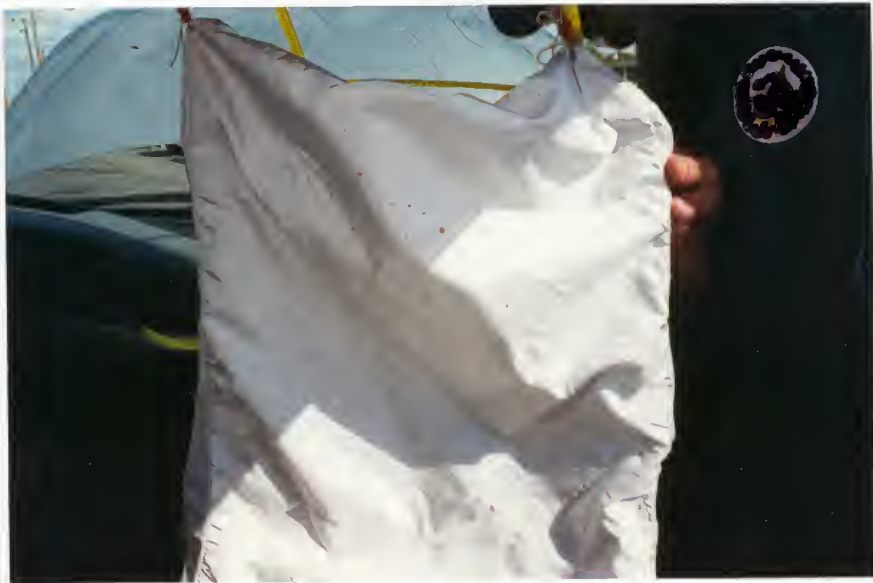
Three blood spatter patterns were noted to the front right air bag. The first spatter was located 17.8-38.1 cm (7.0-15.0 in) right of the left side of the air bag and 7.6-20.3 cm (3.0-

8.0 in) down from the top of the bag (refer to Photograph No. 70). The second blood spatter was noted 30.5-38.1 cm (12.0-15.0 in) below the top of the bag and 0.0-5.1 cm (0.0-2.0 in) inboard of the right side of the bag (refer to Photograph No. 73). A third blood spatter was located 54.6-58.4 cm (21.5-23.0 in) below the top of the bag and 14.0-21.6 cm (5.5-8.5 in) inboard of the right side (refer to Photograph No. 72). A probable body fluid/material (tissue or nasal expulsion) transfer of 12.7 cm (5.0 in) in length was located on the right side of the passenger side air bag, centered between the side seams and 7.6 cm (3.0 in) above the lower seam. Gray vinyl transfers were present at the bottom right sector of the bag 13.3-5.1 cm (5.15-2.0 in) up from the bottom seam and 7.0-17.8 cm (2.75-7.0 in) left of the right seam (refer to Photograph No. 74-75). These resulted from bag expansion within the module assembly.

70. View of blood spatters on the face of the air bag at the 12 o'clock position.

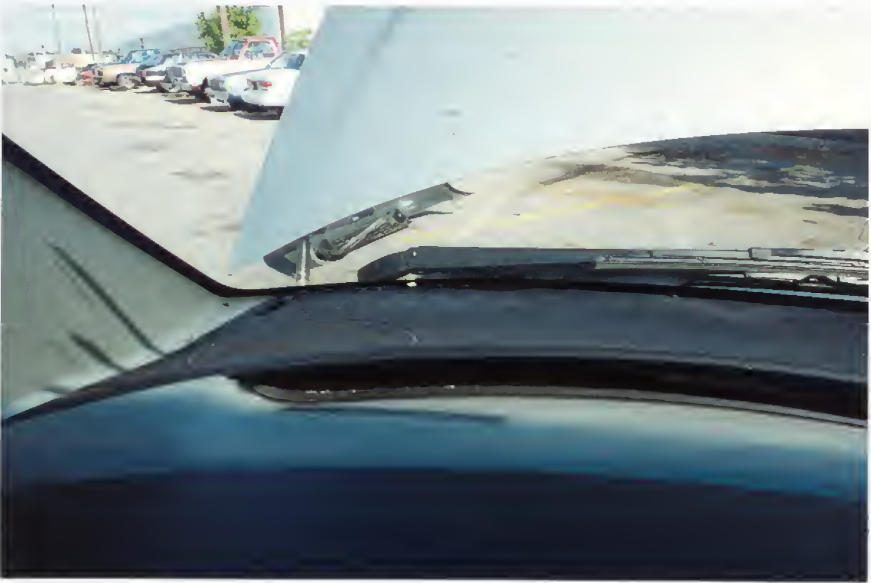
79. View of the avulsed tooth found on the left side of the instrument panel.

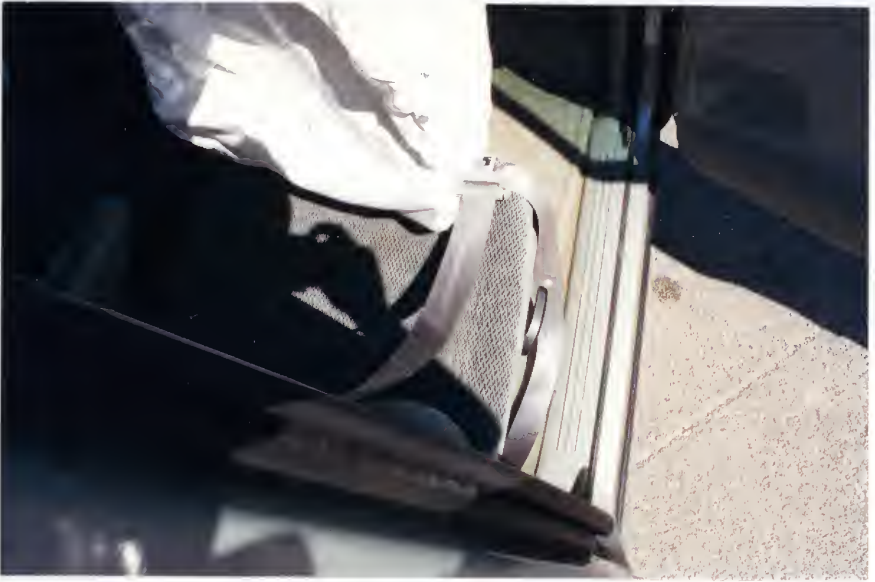
The 5 year old child passenger was seated in the right front position and was restrained by the lap portion of the restraint with the shoulder belt probably positioned behind her back. The right front D-ring was adjusted to the full down position (refer to Photograph No. 85). A faint abrasion was noted on the outboard aspect of the plastic crossbar of the latchplate (refer to Photograph No. 88). There were blood stains noted 7.6-15.2 cm (3.0-6.0 in) outboard of the latchplate on the lap portion of the webbing. There were also eight (8) small blood stains noted on the shoulder aspect of the belt webbing (refer to Photograph N. 87). The stains were located 5.1-15.2 cm (2.0-6.0 in) above the latchplate. These stains probably were deposited after the child rebounded back under the shoulder belt webbing in the later stages of the crash sequence. A fluid spill was also noted on the right front restraint webbing (refer to Photograph Nos. 89-92), however, this did not appear to be related to the crash.

89. View of a fluid spill on the right front restraint webbing.

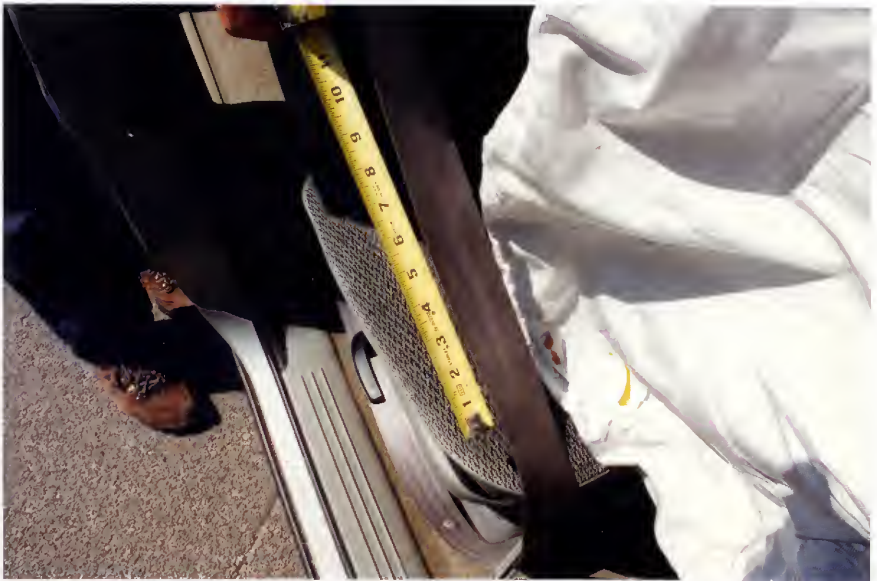
90. View of a fluid spill on the right front restraint webbing.

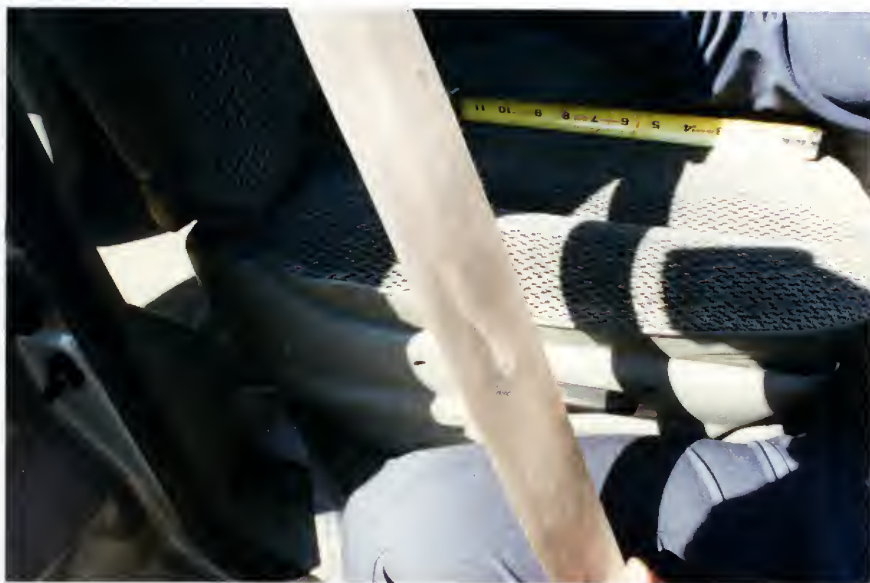
92. View of the fluid spill. Note, this is the reverse side of the webbing.

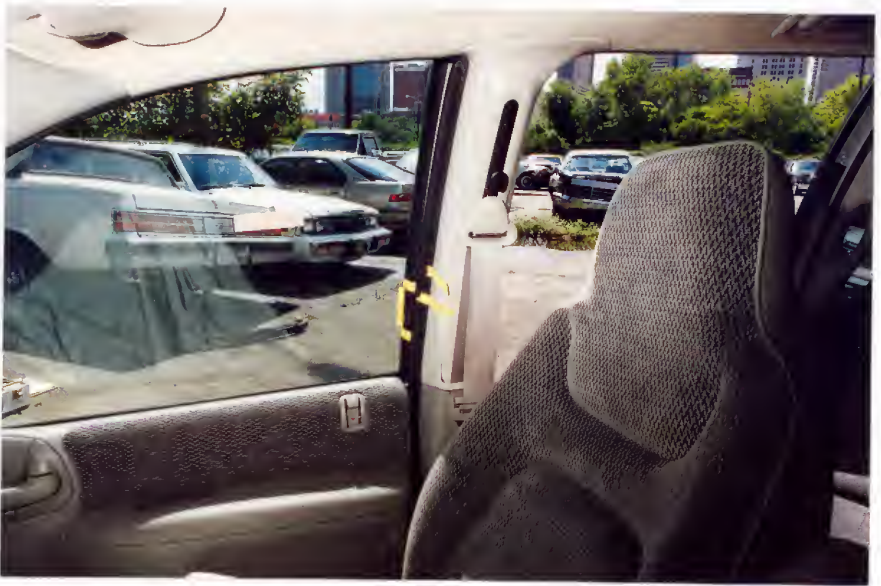
The posterior scalp of the front right child passenger impacted the right upper B-pillar and door window frame during her rebound trajectory. The rubber strip at the trailing edge of the right front door window was deformed by the head contact. The deformed area of the gasket involved 5.0 mm (0.2 in) of compression. The compression was located 11.1-13.7 cm (4.4-5.4 in) above the beltline and 47.0 cm (18.5 in) above the seat cushion (refer to Photograph No. 93-95). A dark oily smudge was noted on the B-pillar 17.1-18.4 cm (6.75-7.25 in) above

93. View of a rebound contact at the right B-pillar/window juncture.

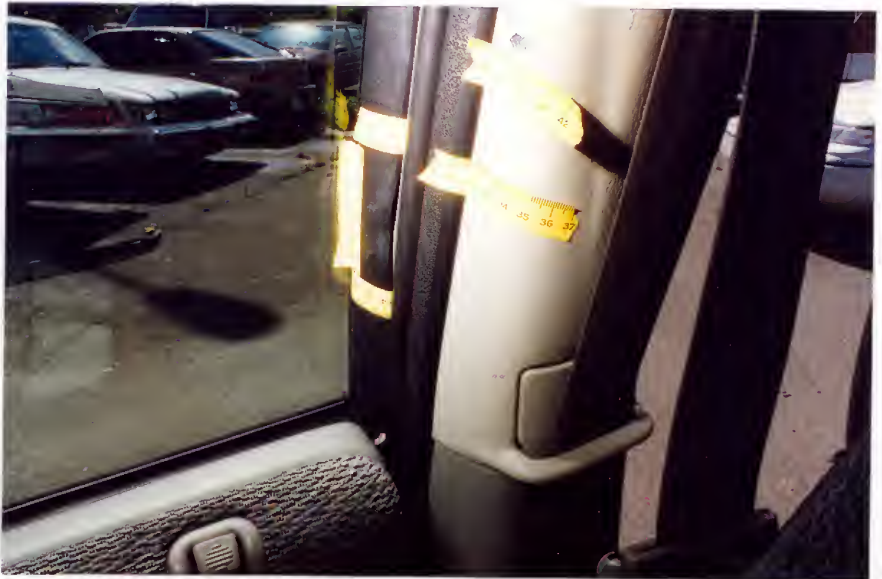
94. Close-up view of the rebound contact.

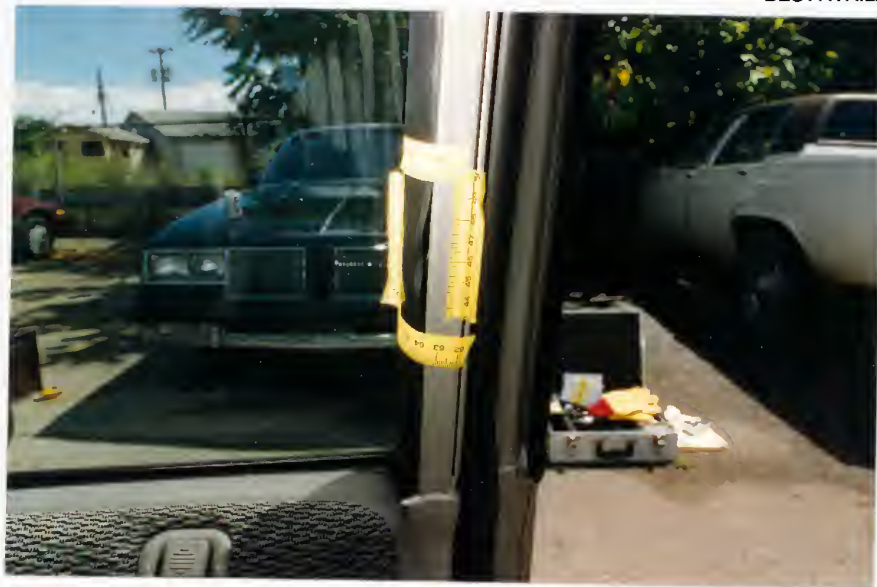
95. Close-up view of the rebound contact.

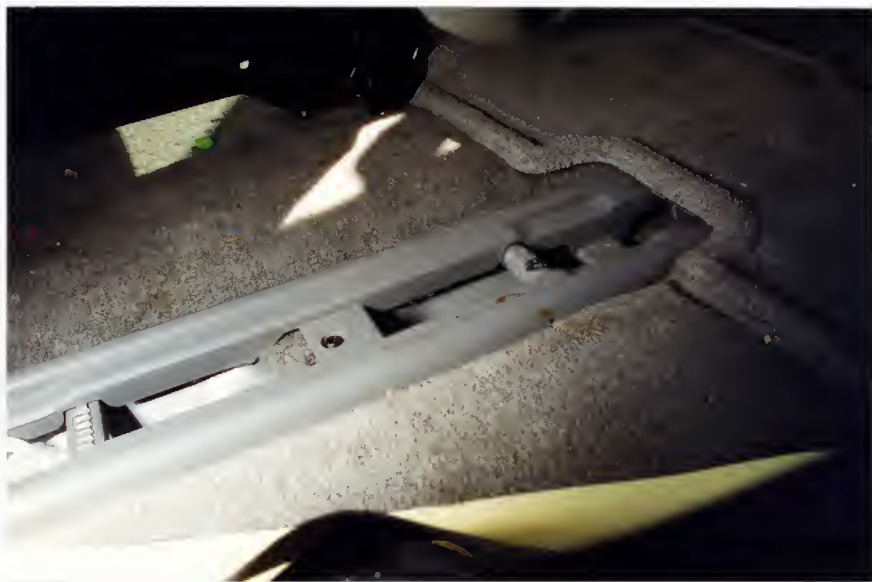
The left side mounting point of the second seat (removable) completely disengaged from the floor locking point (refer to Photograph No. 97). A toddler was restrained in a forward facing child safety seat in the left side of the second seat. The shoulder belt at this position sustained a large abrasion from the plastic extrusion at the outboard aspect of the seat cushion/seat back juncture. The abrasion measured 11.4 cm (4.5 in) vertical and 3.8 (1.5 in) horizontal (refer to Photograph No. 102-103). An additional D-ring transfer was noted on the webbing located 195.6 cm (77.0 in) above the floor anchorage.

98. View of the second seat's left side floor mount.

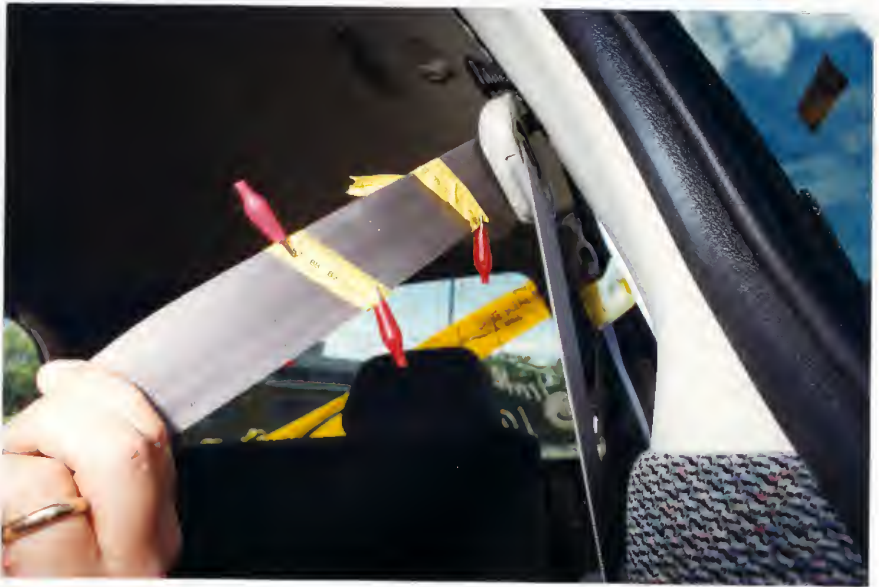
child safety seat on the seat cushion. Abrasions were noted to the shoulder belt webbing and to the plastic extrusion at the seat cushion/seat back juncture. In addition, the loading produced a D-ring transfer to the shoulder belt webbing. This evidence is documented in Photograph Nos. 97-102.

101. Close-up of an abrasion on the upper portion of restraint webbing near the D-ring.

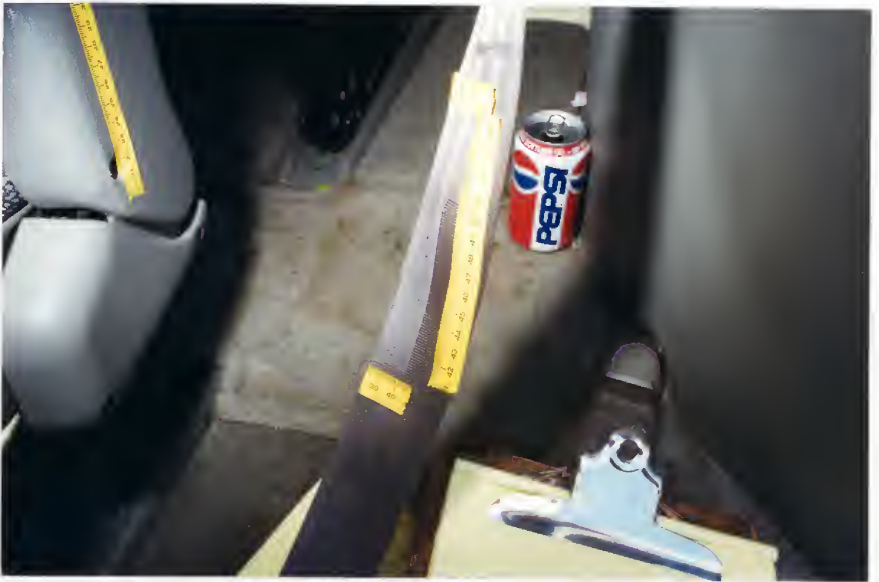
102. Close-up of an abrasion on the restraint webbing caused by the plastic cover.

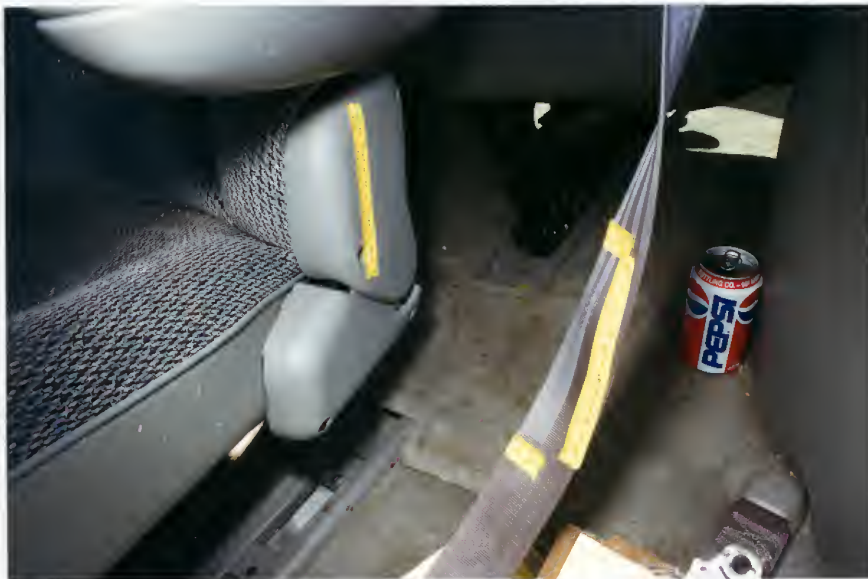
103. Close-up of the abraded surface of the second seat's hinge cover.

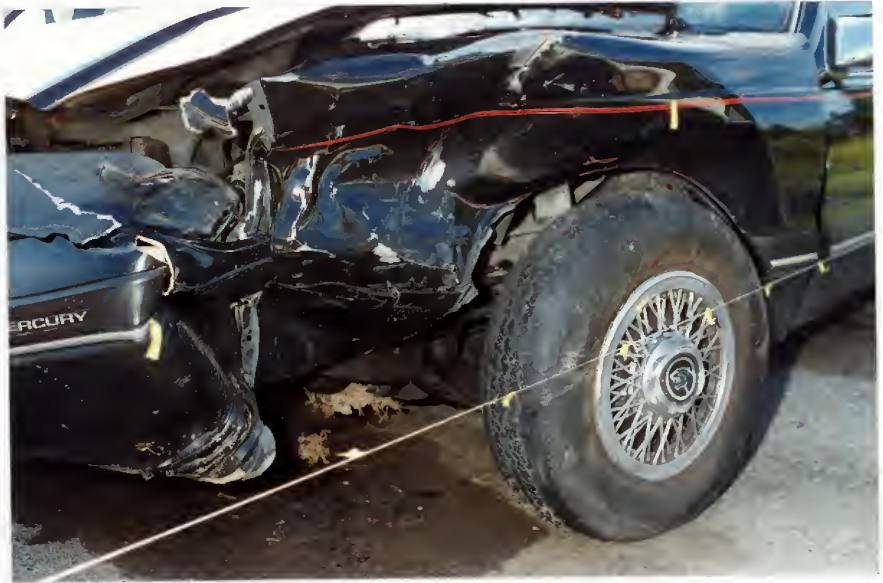
The 1988 Mercury Cougar sustained moderate left side damage from its impact sequence with the Dodge Caravan. The direct contact damage began 8.9 cm (3.5 in) rearward of the left front axle and extended 99.1 cm (39.0 in) forward to the front bumper corner. The combined induced and direct contact damage began at the trailing edge of the left front fender and extended 141.5 cm (55.75 in) forward to the bumper corner. Maximum crush was 50.1 cm (20.0 in) located at the leading edge of the left front fender, 61.0 cm (24.0 in) forward of the left front axle. The crush profile was as follows: C1=0, C2= 13.0 cm (5.1 in), C3=22.9 cm (9.0 in), C4=34.3 cm(13.5 in), C5=35.8 cm (14.1 in), C6=27.4 cm (10.8 in).

107. Close-up view of the direct contact damage.

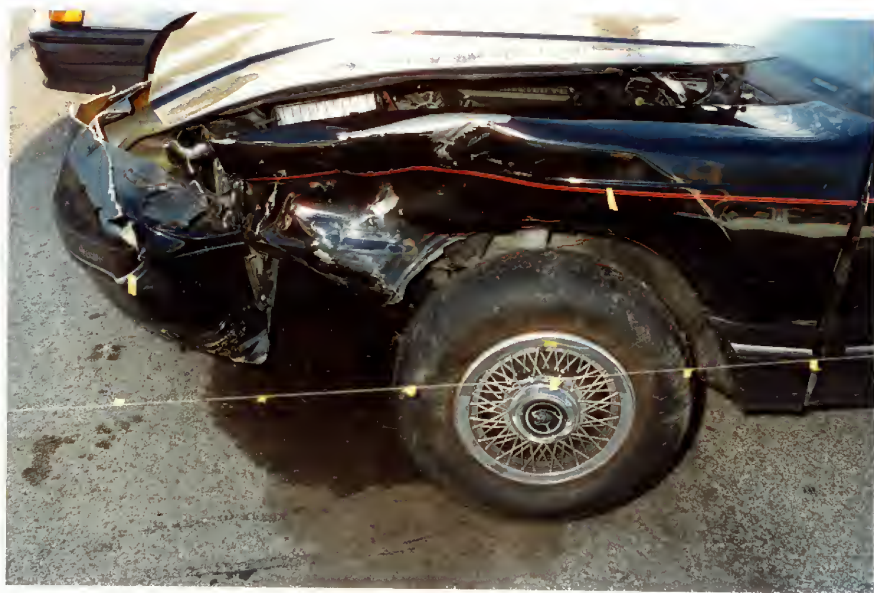
108. Left side view of the direct contact damage.

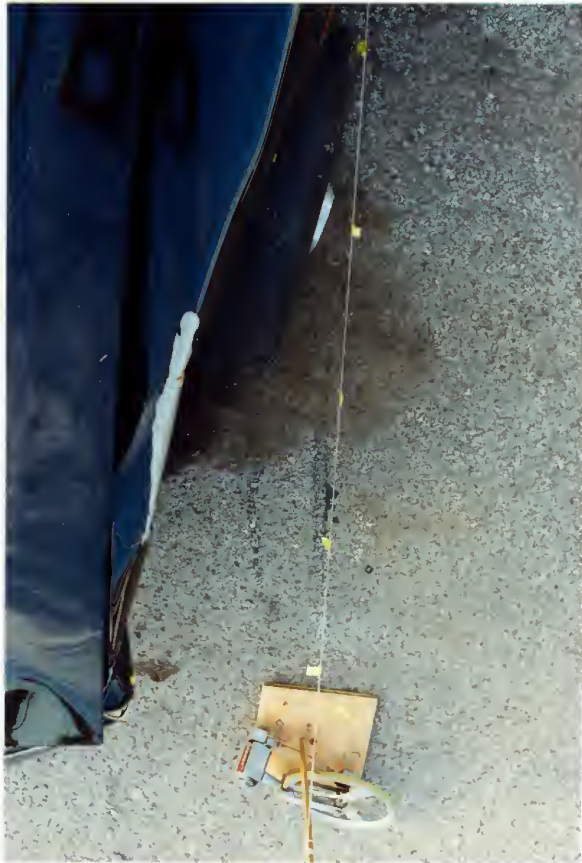
109. Overhead view of the deformation.

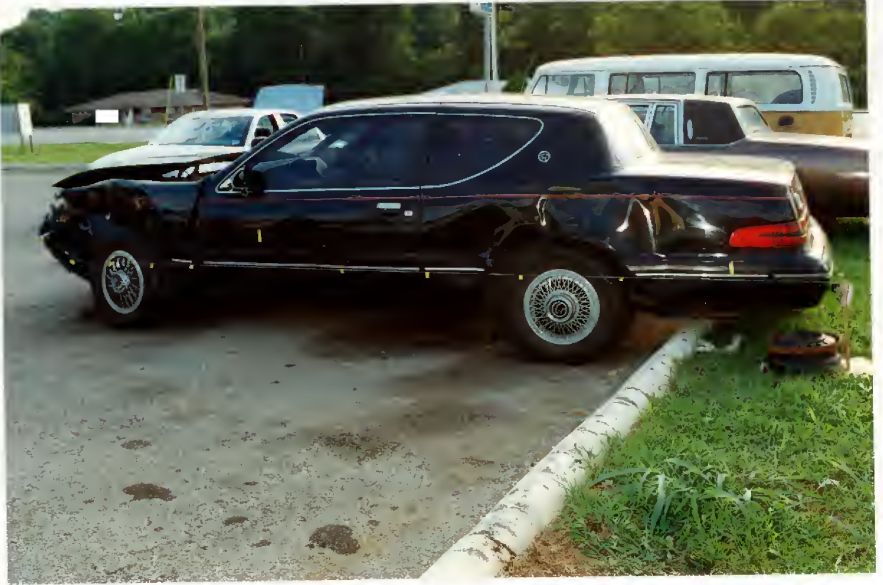
The secondary sideslap damage was minor with a maximum crush of 4.8 cm (1.9 in) located 17.1 cm (6.75 in) forward of the left rear axle. The direct contact damage began 81.3 cm (32.0 in) rearward of the left rear axle and extended 245.1 cm (96.5 in) forward. The crush profile for the sideslap was as follows: C1=0 cm, C2=3.3 cm (1.3 in), C3=4.8 cm (1.9 in), C4=0.6 cm (0.3 in), C5=0.3 cm (0.1 in), C6=0 cm. The left side rear view mirror, located 91.4 cm (36.0 in) rearward of the left front axle, was fractured by the secondary impact.

112. Left side view of the secondary (side slap) damage.
